Twyford – Flood and Coastal Defence Investigation Report

July 2017

The Purpose of this report is to provide information on the current risk of flooding and to suggest options that may be used to mitigate flood risk at this location based on the current evidence.

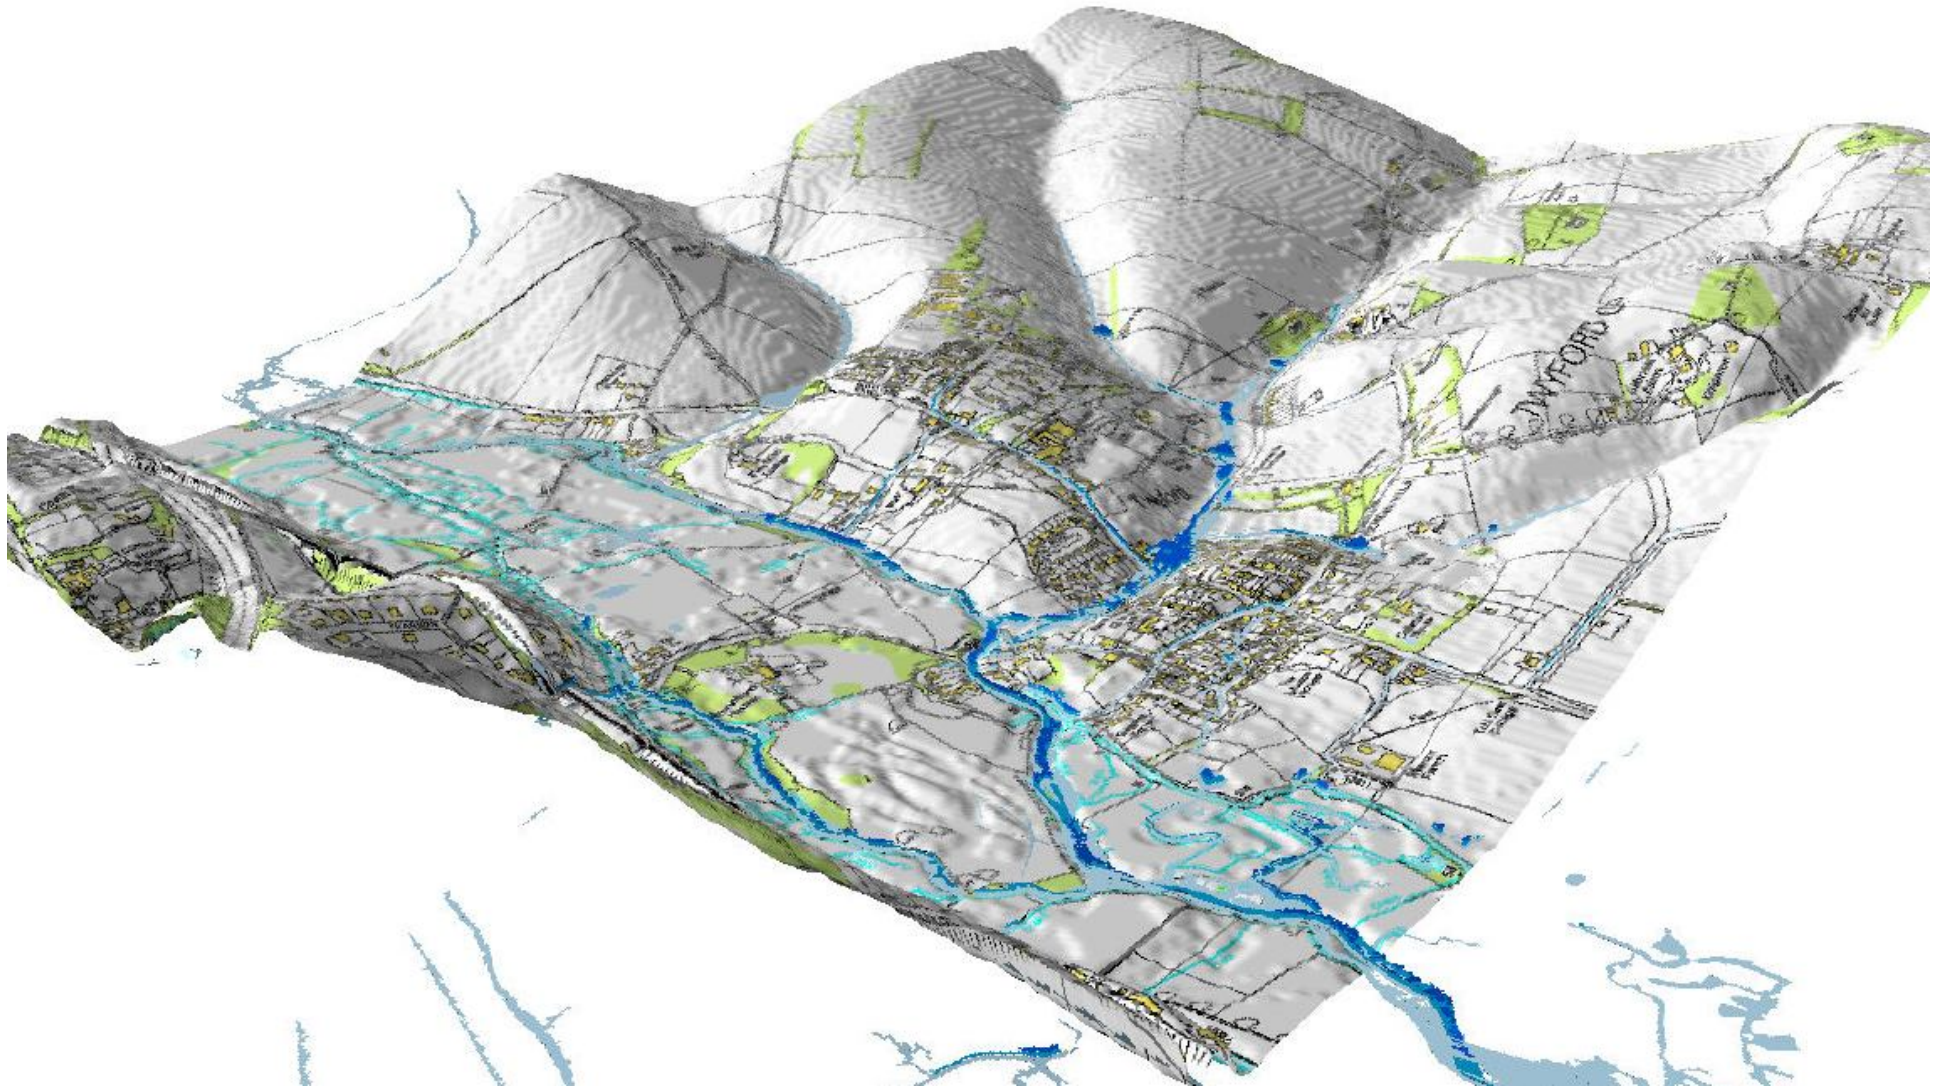
Figure 7: Isometric map of Twyford overlain with surface water flood layer.

An initial review of the existing desktop information was undertaken. Figures 6 and 7 are provided for information in relation to existing drainage assets and the general topography of the surrounding areas.

8. This point in the road is where the majority of the flooding occurs then this backs up and floods the car park to the rear of the Parish Hall. The surface water flood maps in figure 4 clearly correlate with this and show an area susceptible to surface water flooding.

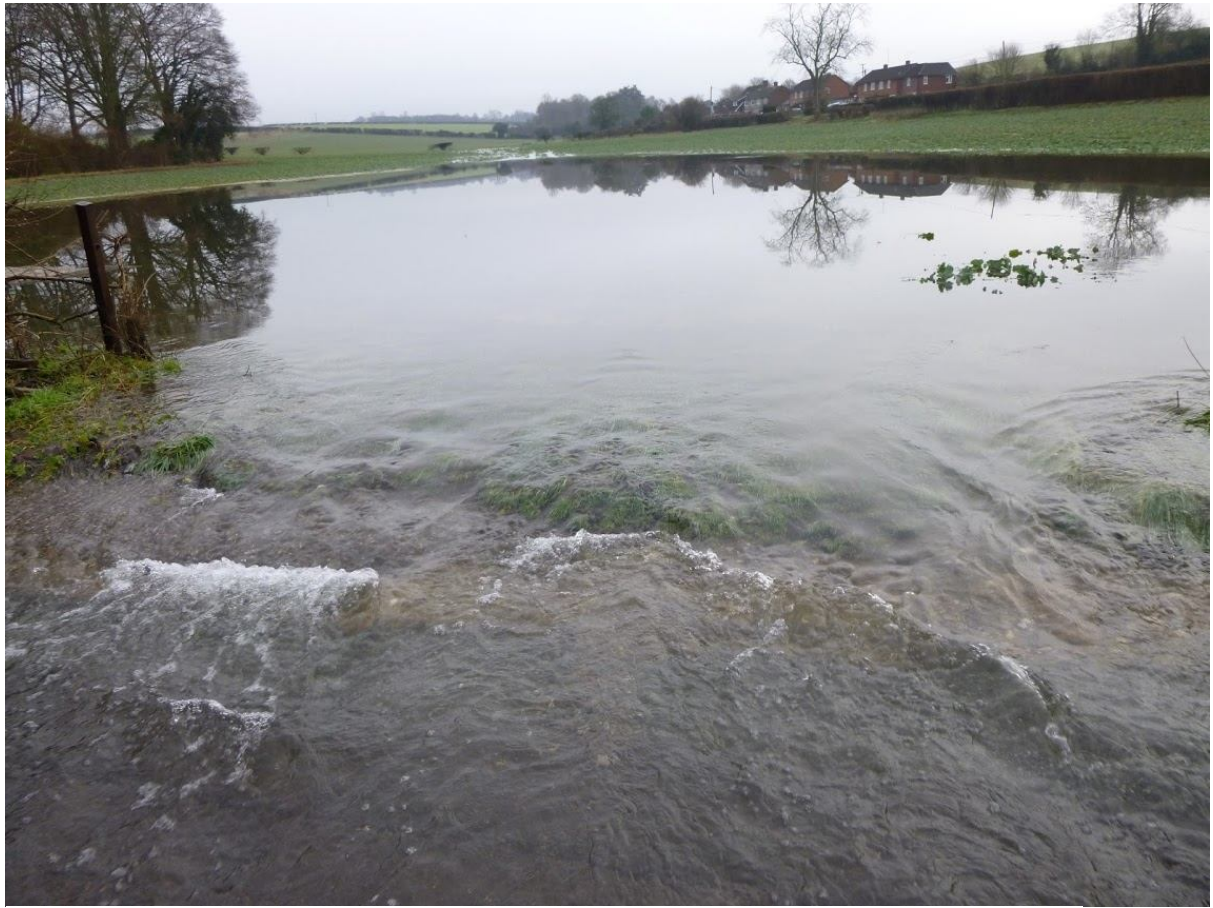
Plate 1
Ponding in field to the east of Bourne Lane

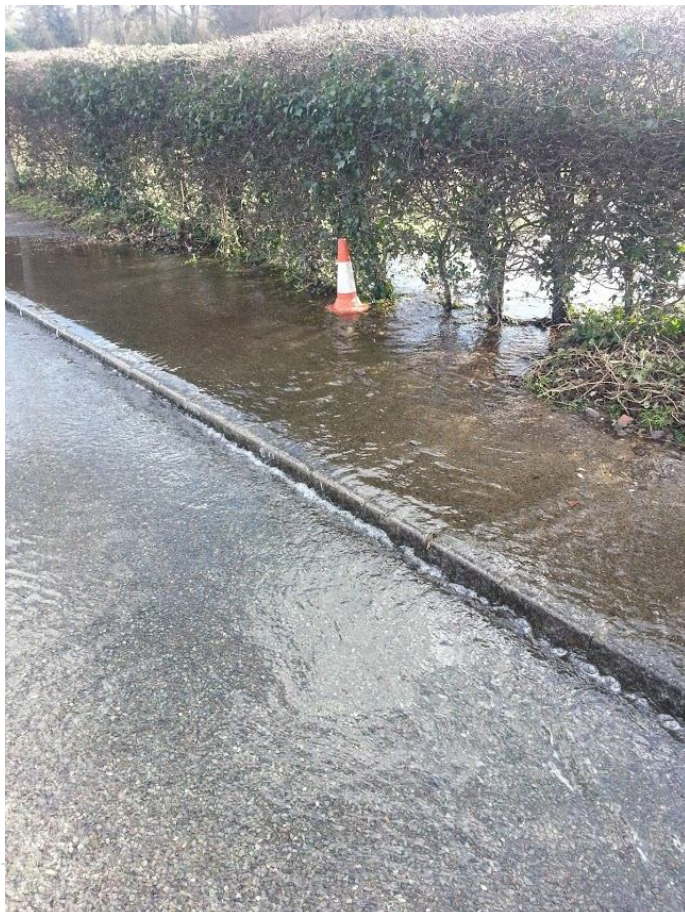
Plate 2
Water flows from Littlebourne Field
onto Hazeley Road

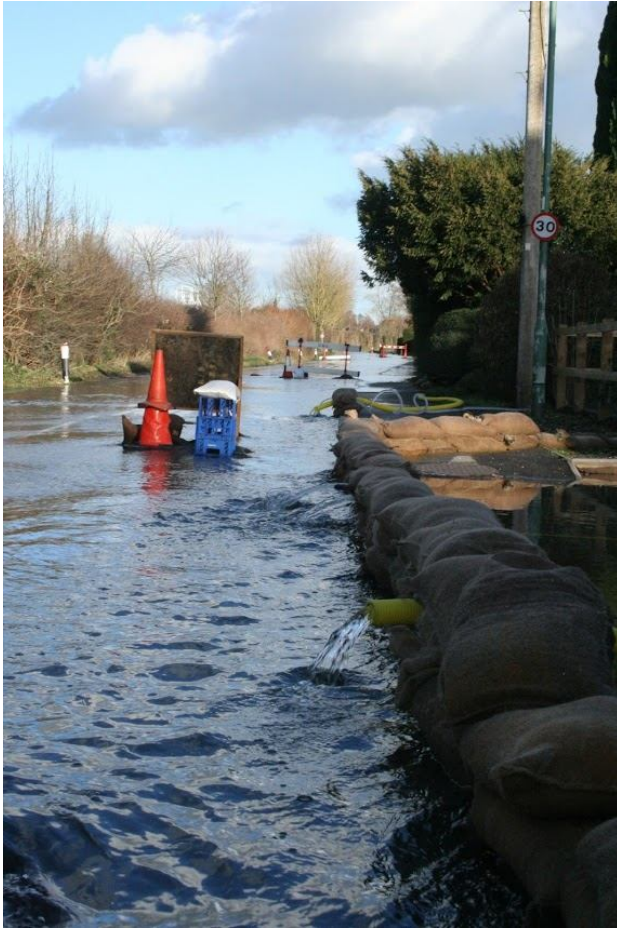
Plate 3

Flooding of Hazeley Road and pumps from properties discharging onto the highway

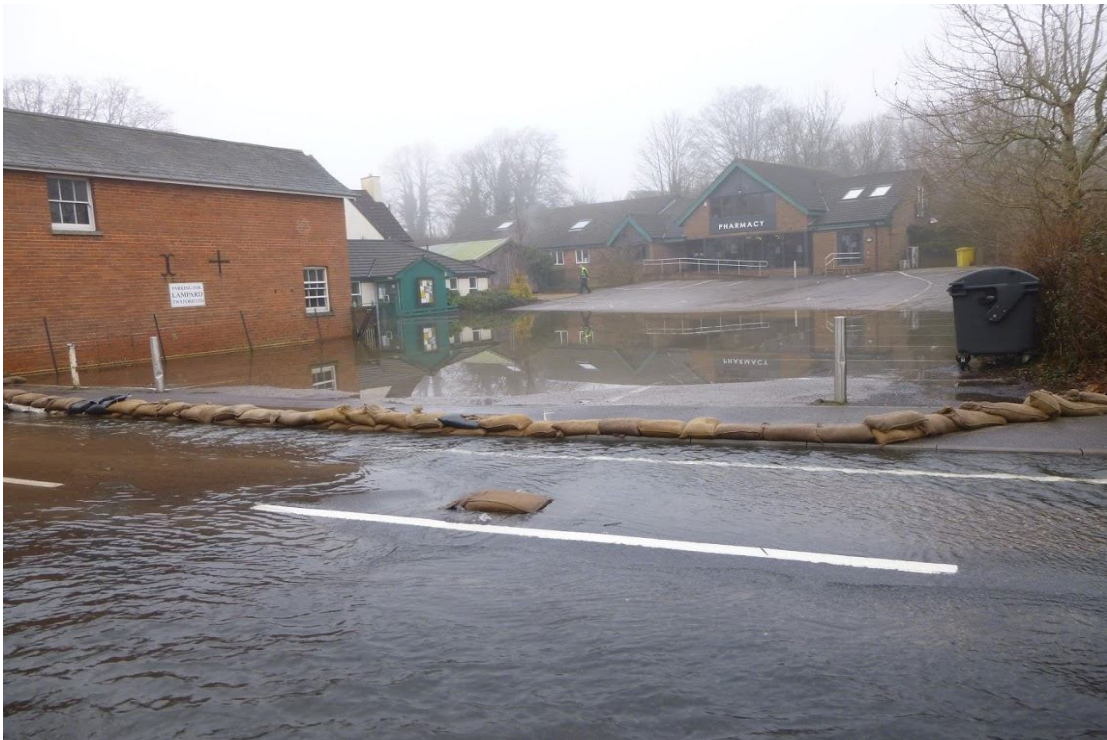
Plate 4

Flooded area of Parish Hall / Surgery car park

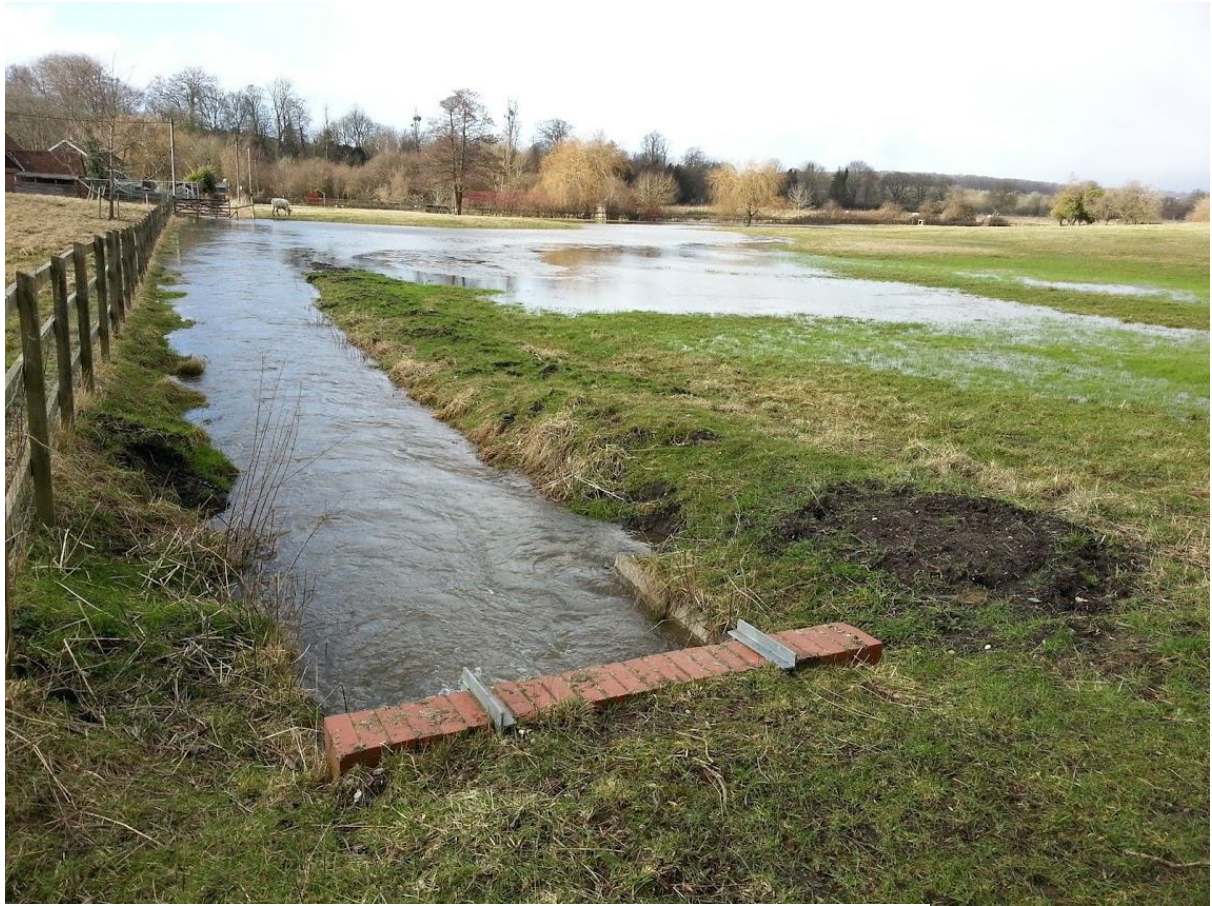
Plate 5
Flooded fields to the north of Finch's Lane

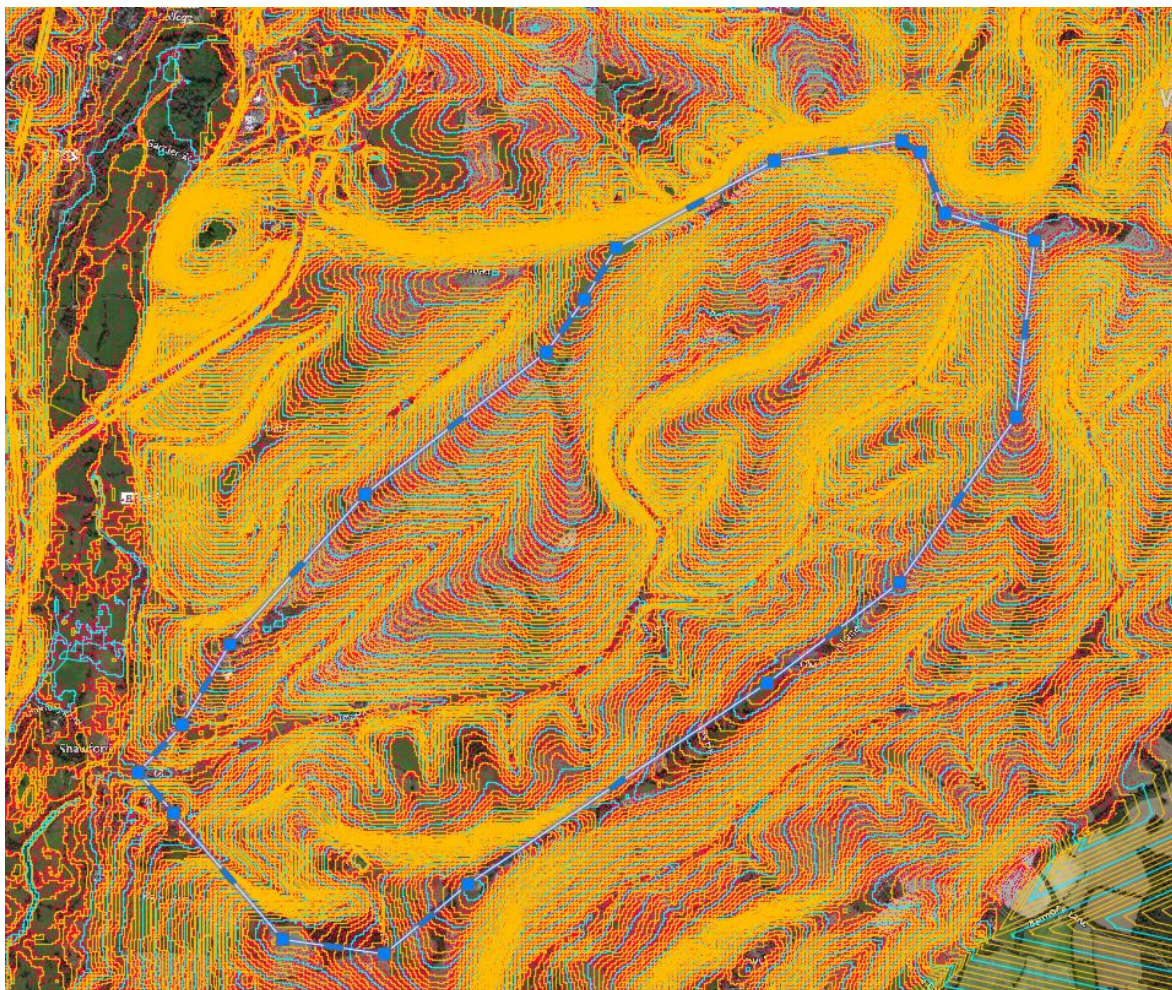
The contour data suggest that the size of the area directly feeding surface water and winterbourne run off is approximately **1150 hectares**. The high point is estimated to be near the A272 and is bounded by Chilcombe in the north and south Morestead on the south.

This area, delineated by the blue line, is pictorially represented within the following figure. The contours blue (5m) and orange (1m) show the lie of the land.

Analysis of the catchment size suggests that over one thousand hectares of land area drains to this particular point at Hazeley Road, and ultimately to a 750mm diameter pipe at the end of Finch's Lane.

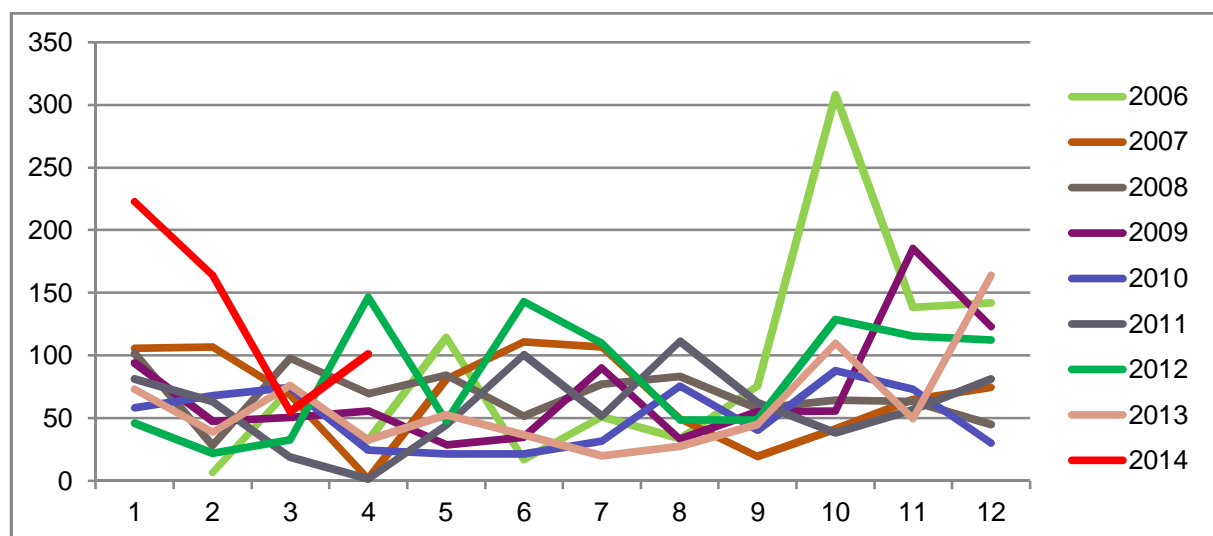
The rainfall data were collected from the observational weather stations in the local area and collected as a time-series. Analysis of the data suggests that 2012 and 2010 were particularly bad years for rainfall, but because the cumulative or rolling summation with respect to time stayed below a certain threshold, the winterbourne stayed below ground. These facts are particularly interesting as they help set an upper bound to the capacity of the soil (described below) to convey water without flooding. It was only in the winter of 2013 and subsequent cumulative early rainfalls in 2014 which led to the emergence of the winterbourne around about the 12th of January, and which is reported to have lasted two months almost to the day, i.e. the 12th of March, 2014. It was at this point the cumulative rainfall had relaxed sufficiently to let the winterbourne subside and disappear back under ground. These data help with later analysis and are used as a multiplier with the catchment area to determine the product of the winterbourne flow (volume over time), in subsequent calculations.

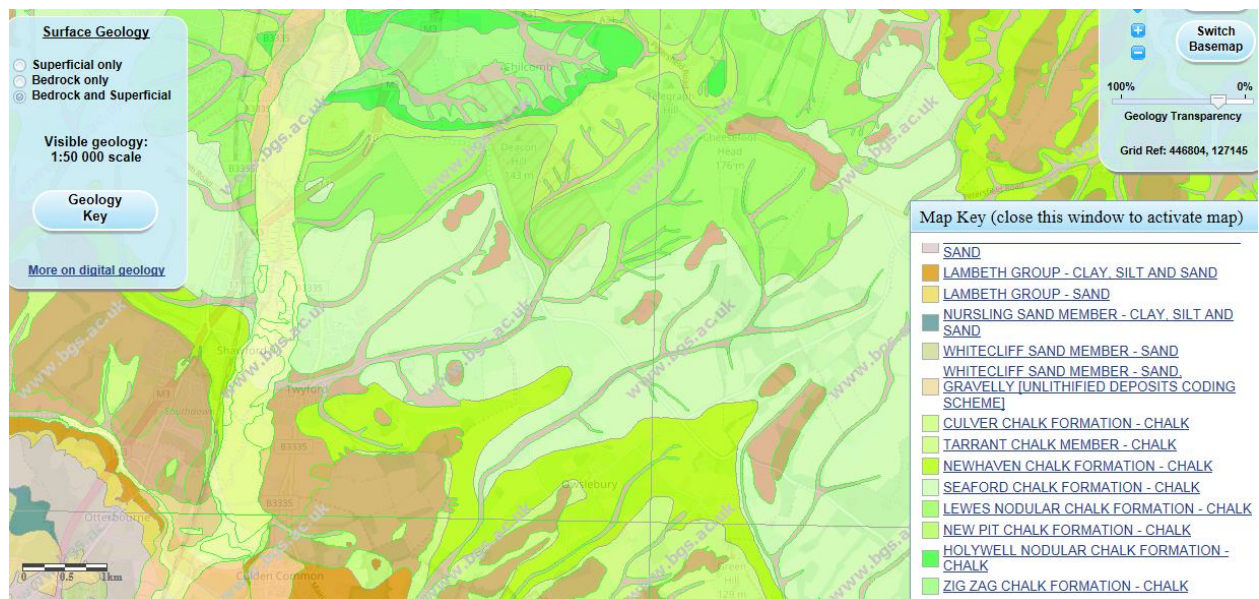
UK Geological survey maps state that the bedrock layers within the catchment are largely chalk based. The characteristics of chalk layers are that they convey relatively large flows of groundwater fairly easily. As can be inferred from the maps, the valleys are covered in clay which acts as a barrier to the conveyance of water. The net effect of this layering is that once the chalk layers have reached their full potential to convey groundwater, the surplus rainfall emerges to the surface and traverses along the top of the less permeable clay geography within the valley floor as a winterbourne.
