**TWYFORD PARISH COUNCIL  
TWYFORD FLOOD ALLEVIATION  
SCHEME  
TWYFORD**

**FLOOD ALLEVIATION PROPOSALS**

**JUNE 2019**

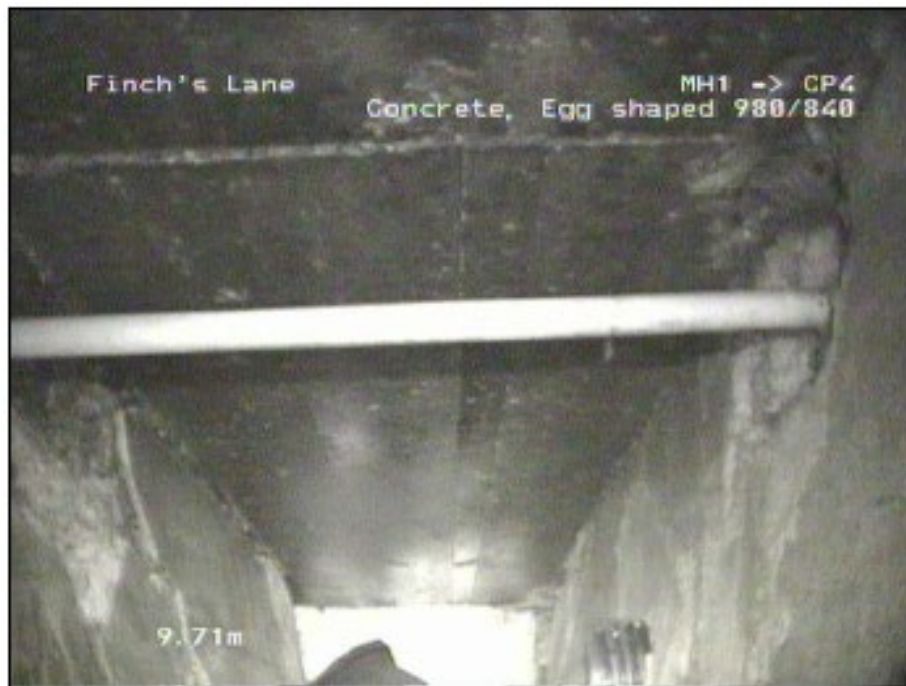
**Figure 3.3 – Utility connection**

- 3.8 Figure 3.3 shows a utility pipe crossing the sewer. There are 3 instances of utilities crossing through the sewer network. These will marginally reduce the capacity of the sewer and cause turbulence in the water flow. They may also obstruct detritus within the flow causing further restriction.
- 3.9 There are several instances of longitudinal cracking in the sewer network as can be seen in Figure 3.4. They have the potential to collapse and could lead to subsidence/collapse in the surface above. The instance in Figure 3.7, is below an area where cars normally park so poses a high risk.

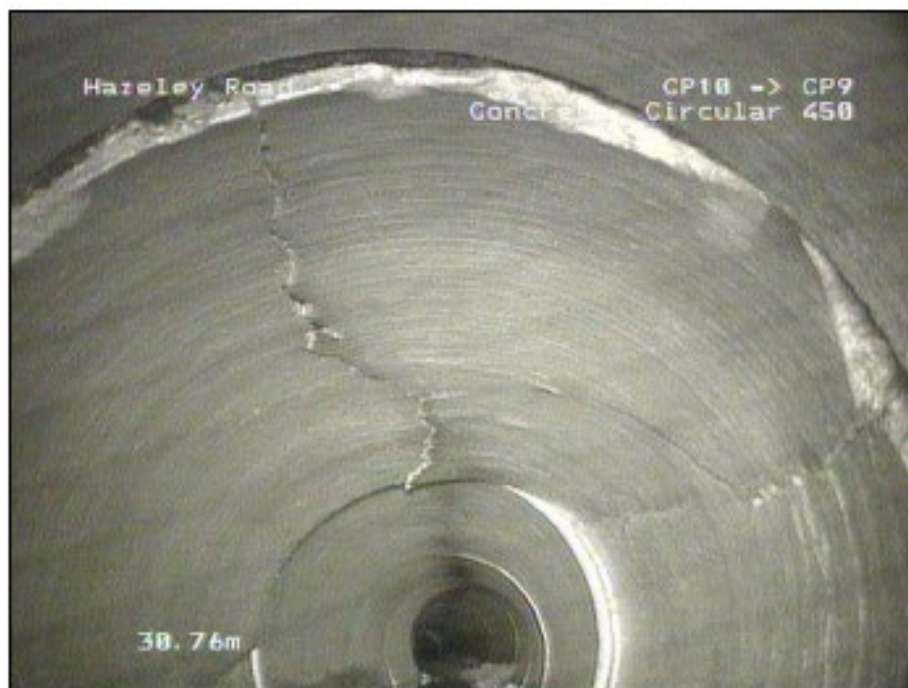
**Figure 3.4 – Longitudinal cracking**

| Reference | Sewer Element | Condition/Issue | Risk | Impacts |
|---|---|---|---|---|
| M1 | Sewer Pipe | Longitudinal cracking in the top of the pipe | Medium | Large amounts of cracking in the top of the pipe which could cause it to collapse. One critical areas is situated below the parking bay and so could create a hole in the surface |

- 6.4 The third item, which is currently not affecting the system, would be the longitudinal cracking in the top of pipes in the vicinity of the Parish Hall car park as seen in Figure 3.4. This, however, is a potential safety and flow issue if it was to collapse. If it was to collapse it would completely block the sewer stopping all flow. In addition to this, it will pose a safety issue as cars park directly above the cracked pipe.

| Potential Improvements and Repairs to Aid Flowrate | | |
|---|---|---|
| Priority 6 | Longitudinal Cracking | This is a potential safety and a future flow issue. There are pipes in the system which have significant longitudinal cracking in the top of pipe. Subsequent collapse would block the sewer and compromise the structural stability of the ground above. |

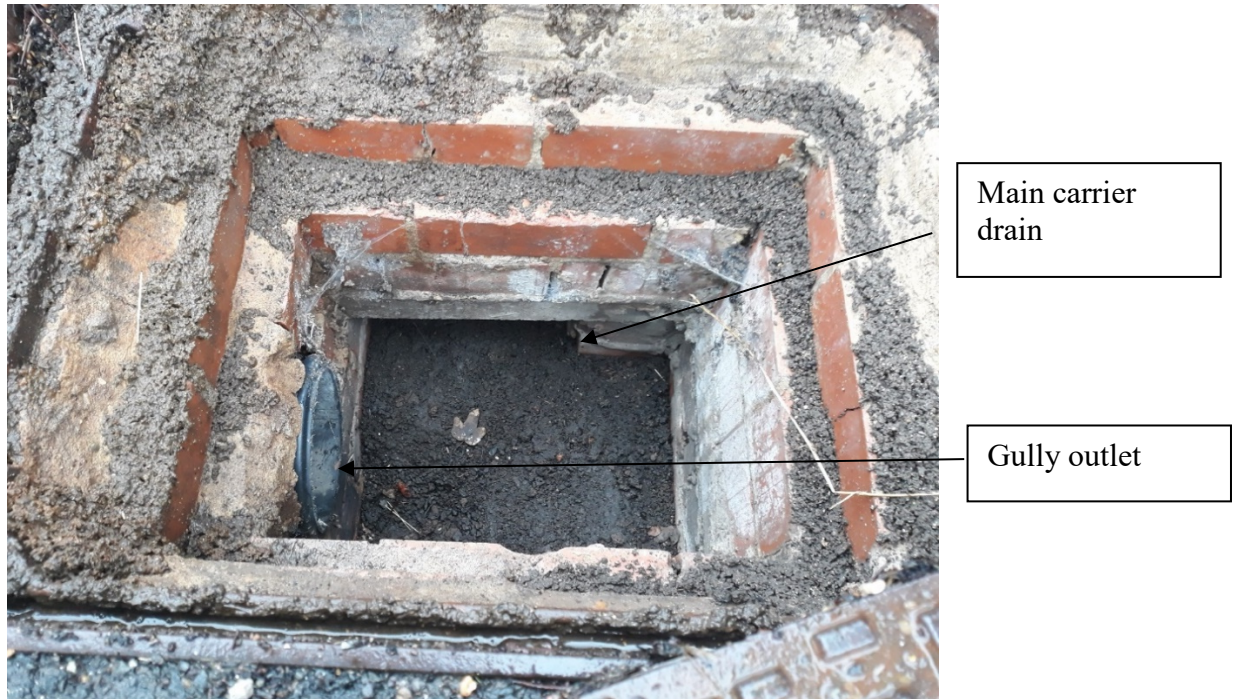
**Figure 3.5 – Partially Blocked Highway Drainage**

- 3.12 From the topographical survey, it was identified that the Hazeley Road is on a balanced crown. The water, therefore, drains to both edges of the highway and runs west towards Hazeley road/Highstreet junction. The first gully that picks up the southern side of the highway is not until Littlebourne Lodge. By this point, there will be a large collection of water on the road which should be discharging into the drainage system. On inspection, the manholes on the south side of Hazeley Road were almost completely blocked as can be seen by Figure 3.5. Subsequently, most of the water arising on the southern side of the road is not discharging into the drainage system. This becomes a bigger problem when as per previous storm events, additional flooding comes onto the highway network from the Littlebourne Fields.

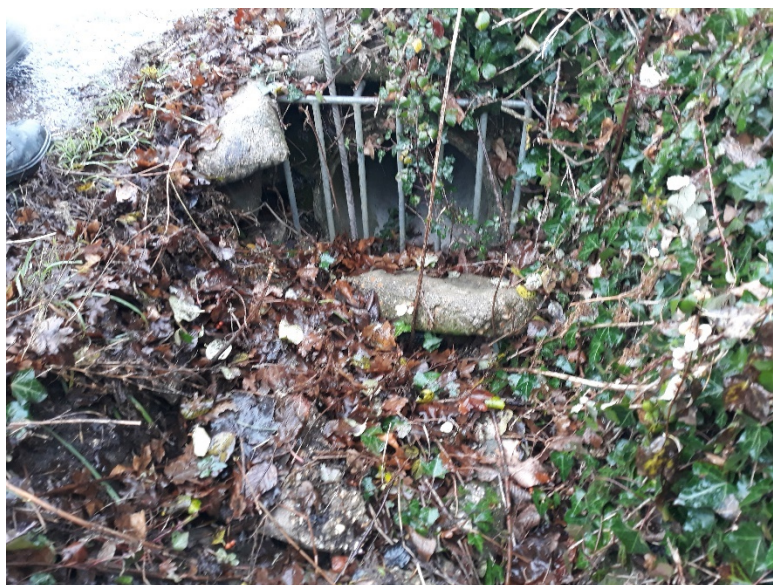
**Figure 3.6 – Concrete Sandbag Headwall**

- 3.13 Along Hazeley road, there are two inlet headwalls constructed of concrete sandbags which are in poor condition. Dislodged sandbags have partially blocked the inlet and in some cases been washed downstream. Further deterioration will risk further blockages. The partially collapsed headwalls will have a detrimental effect on the stability of the adjacent highway and pose a highway safety risk. This is shown in Figure 3.6.

- 6.3 The second priority would be to repair the collapsed concrete sandbag headwall. The headwall is currently blocking the flow of water into the network. Furthermore, if the sandbags become dislodged, they could block the sewer further downstream. There is also the potential for it to impact the structural stability of the adjacent highway.

| Potential Improvements and Repairs to Aid Flowrate | | |
|---|---|---|
| Priority 2 | Repair Collapsed Headwall | The headwall is currently blocking the flow of water into the network. Furthermore if the sandbags become dislodged they could block the sewer further downstream. There is also the potential for it to impact the structural stability of the adjacent highway. |

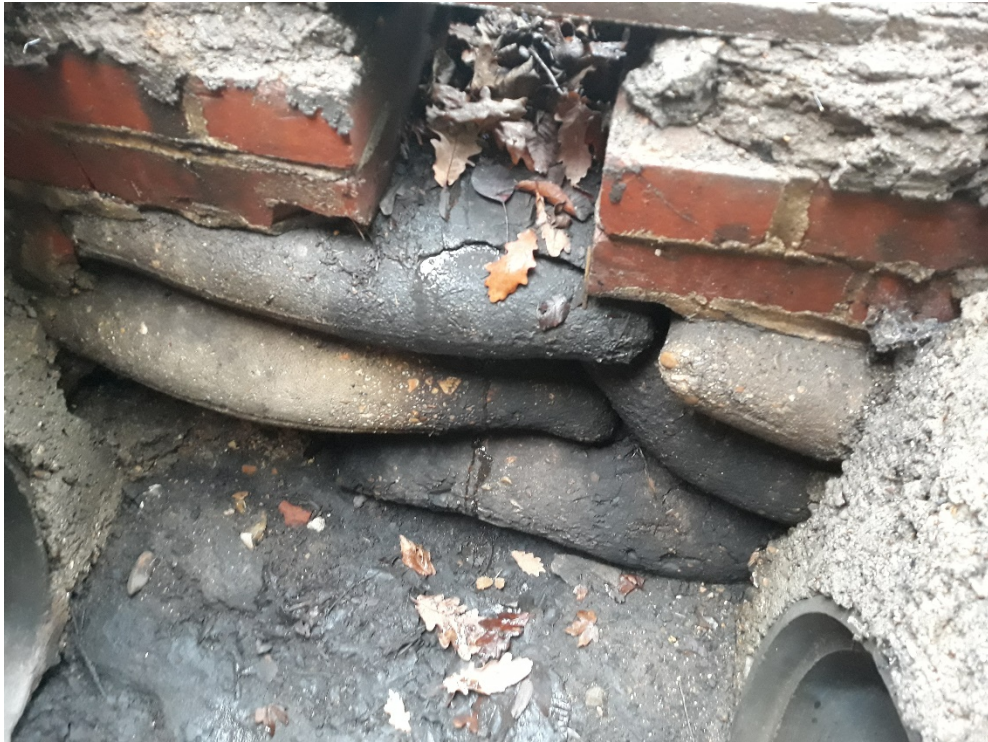
**Figure 3.7 – Concrete Sandbag Manhole**

- 3.14 The majority of the manholes are in good condition. Some of the manholes use concrete sandbags as a structural element as can be seen in Figure 3.7. These are in poor condition and if they become dislodged, they would impact the structural integrity of the manhole and adjacent kerbing and raise the risk of blockages/reduced capacity in the drainage system downstream.

| Reference | Sewer Element | Condition/Issue | Risk | Impacts |
|---|---|---|---|---|
| L3 | Concrete Sandbag in Manhole | Poor condition of concrete sandbag headwall | Low | Potential for sandbags to become dislodged blocking the sewer downstream and potentially compromising the structural integrity of the manhole |

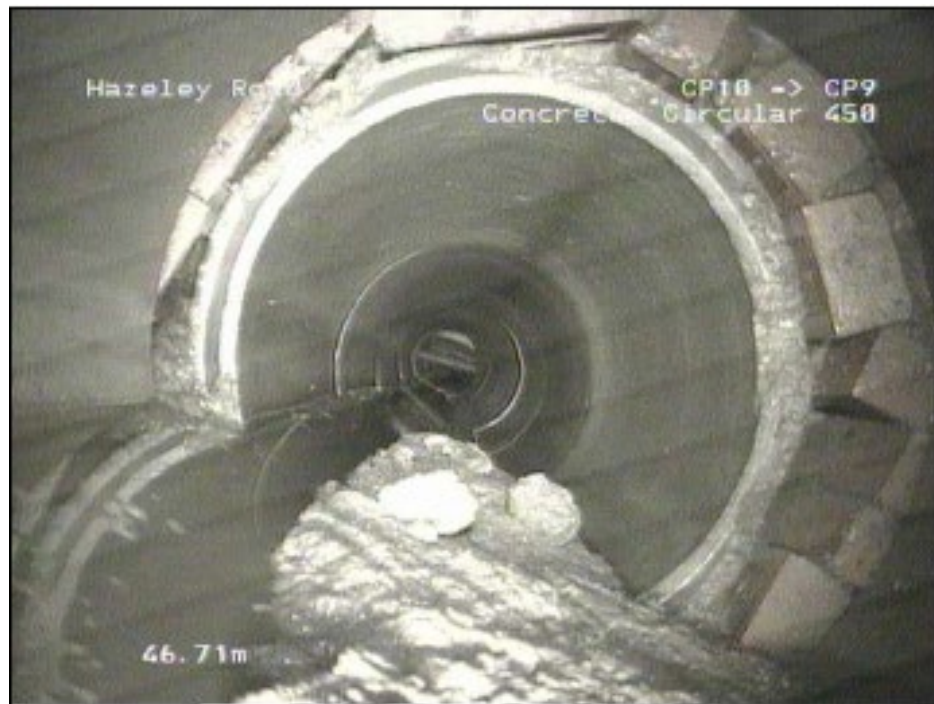
**Figure 3.8 – Sewer Settlement**

- 3.15 There are numerous instances of debris in the pipes as can be seen in Figure 3.8 and 3.9. The current debris reduces the capacity of the sewer by approximately 20% in the affected areas.

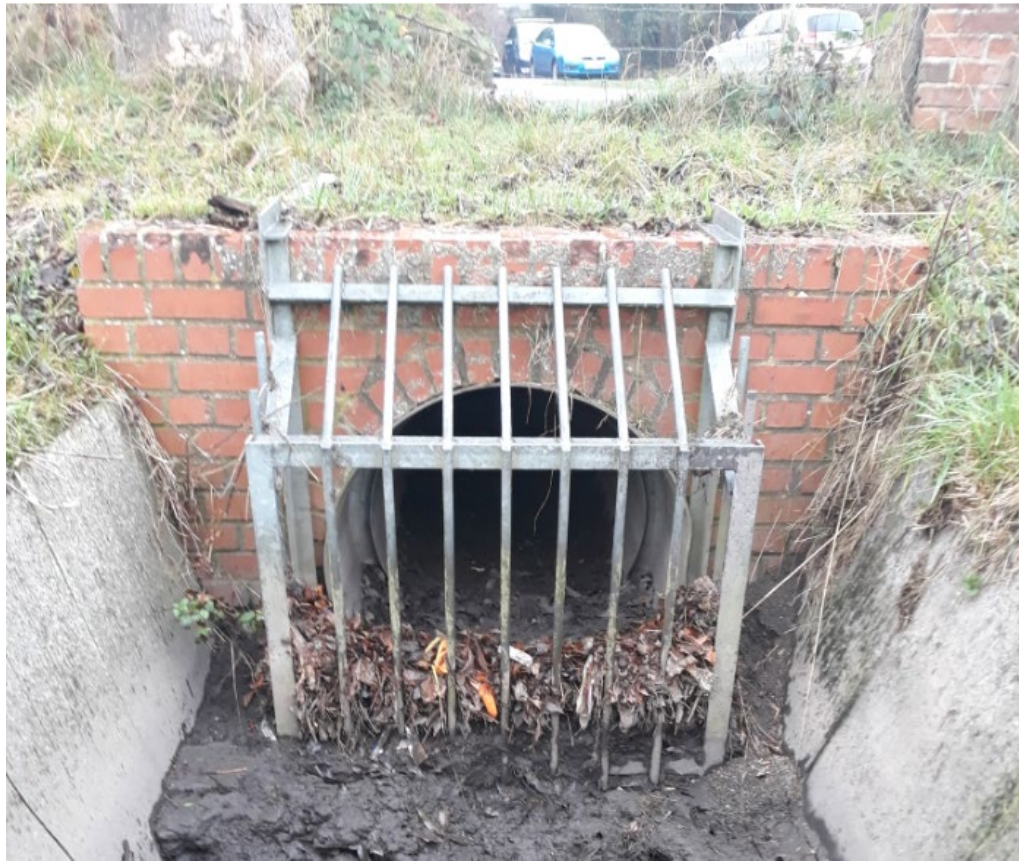
**Figure 3.10 – Outfall Grating**

- 3.16 The outfall for the system has a grating covering it. This blocks the passage of a significant amount of the debris as can be seen in Figure 3.10. This will reduce the capacity of the outfall and also block any large debris from exiting the system

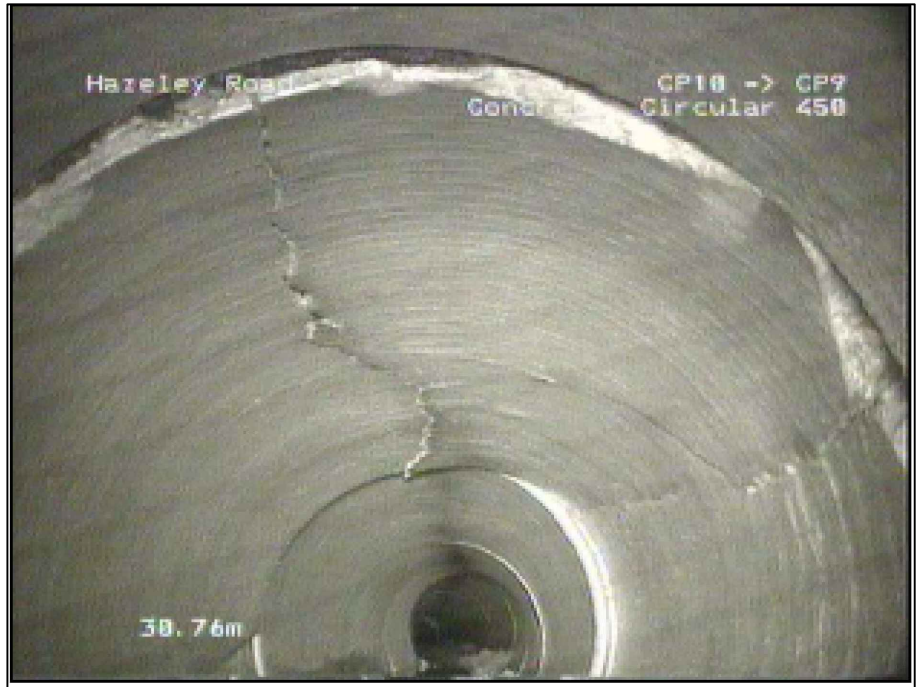
Longitudinal cracking in top of sewer

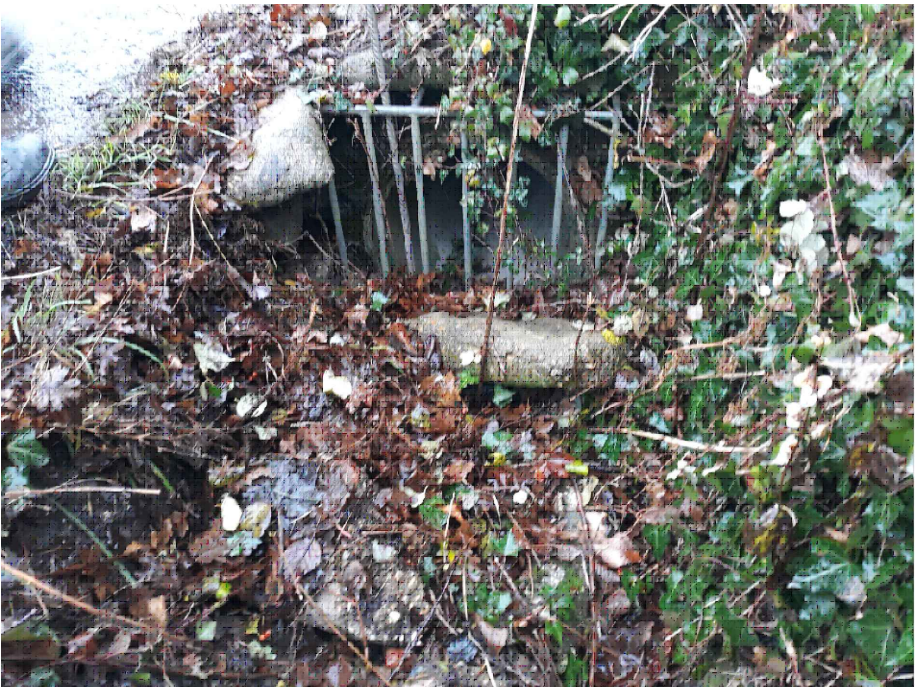
Concrete sandbag headwall collapsing and reducing flow into sewer

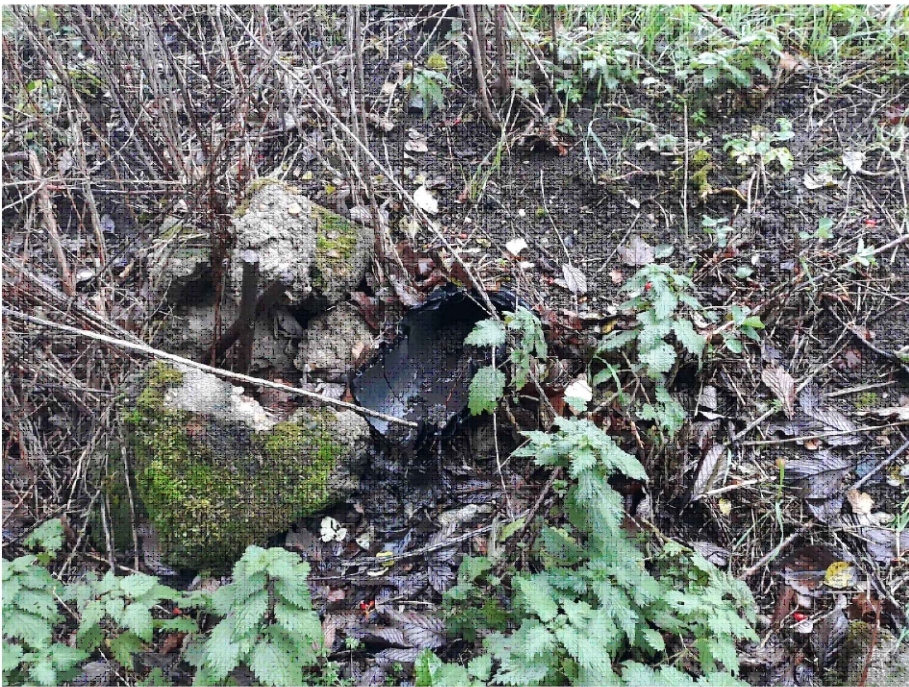
Pipes from road drainage in poor condition and large amount of concrete debris in ditch

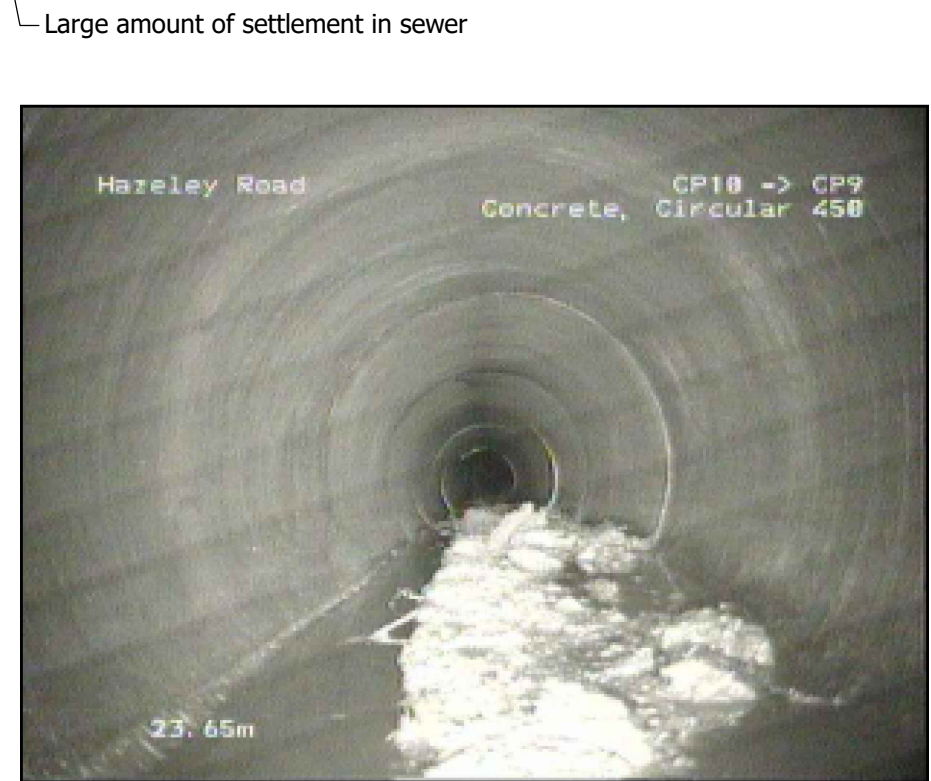
Large amount of settlement in sewer

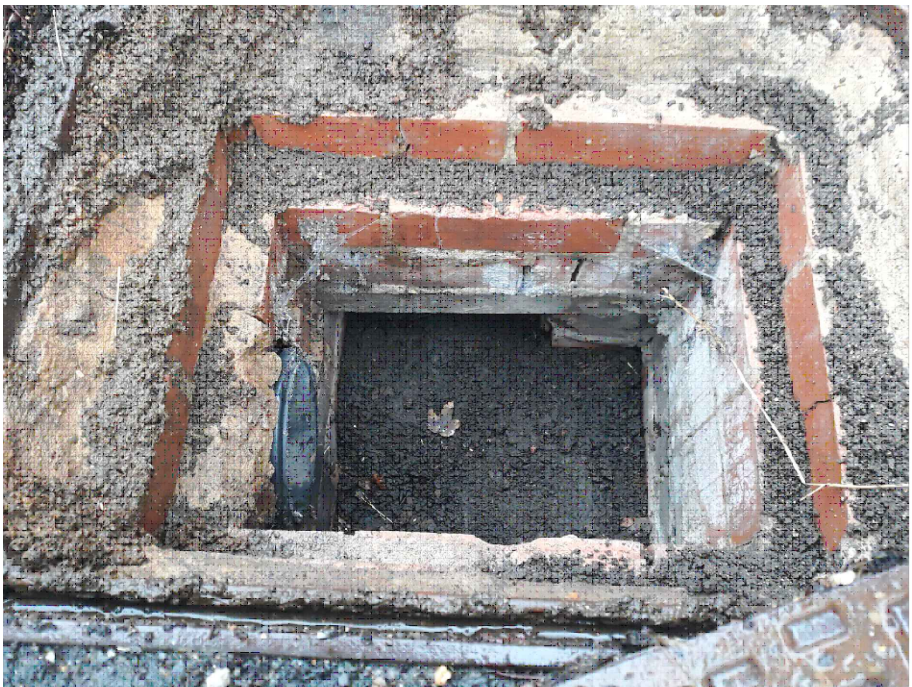
Highway drainage severely undermaintained reducing flow
